Appendix B

Progress Meeting Minutes

Project: Township of South Glengarry
Glen Walter Water Tower and Watermain Replacement

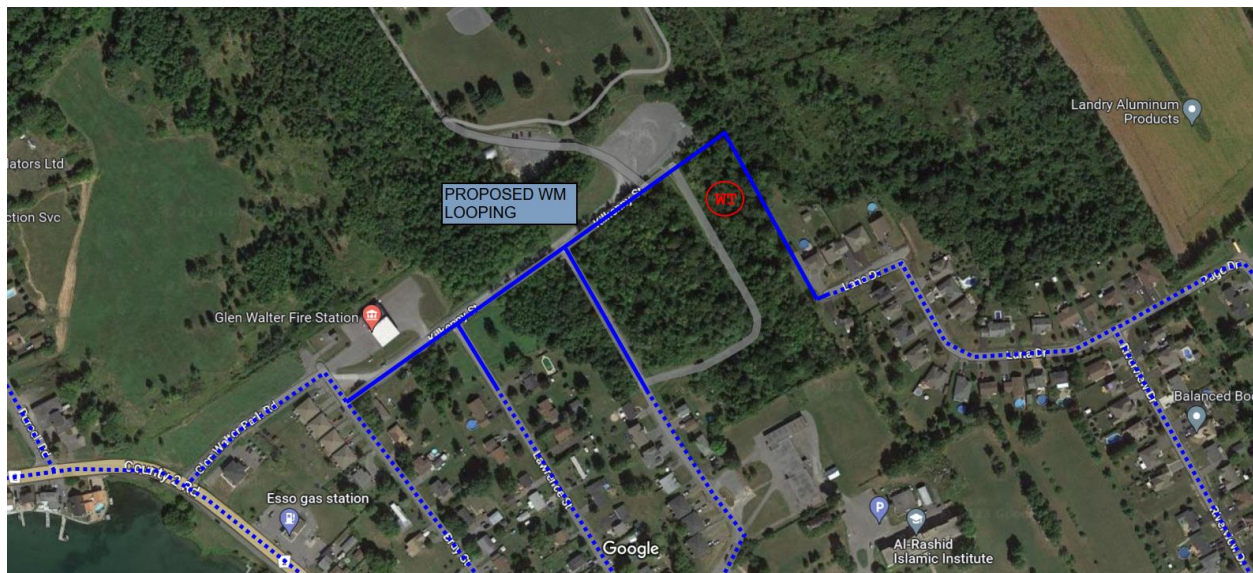
- 1) Our initial water modelling findings show that looping some of the dead end watermain would increase pressure and allow a greater capacity for fire protection without having to potentially replace / upsize the existing watermain.
- 2) Dillen noted that some of the proposed watermain looping (as shown on the sketch below with a solid blue line) has already been completed. Ainley will review the drawings prepared by EVB (received from Dillen by email on March 23, 2023).

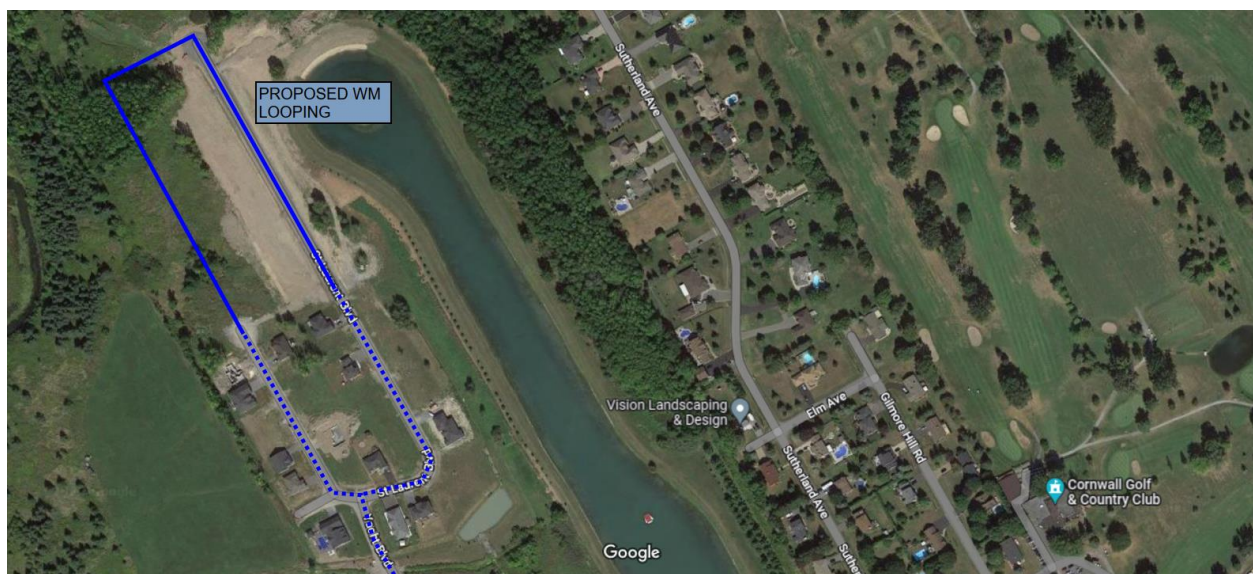
- 3) Dillen also noted that phase 4 and 5 of the St. Laurent Development (located where we show the proposed watermain looping below) is in progress and/or has already been completed. The concept plan for phase 6 currently shows the two roads connecting.

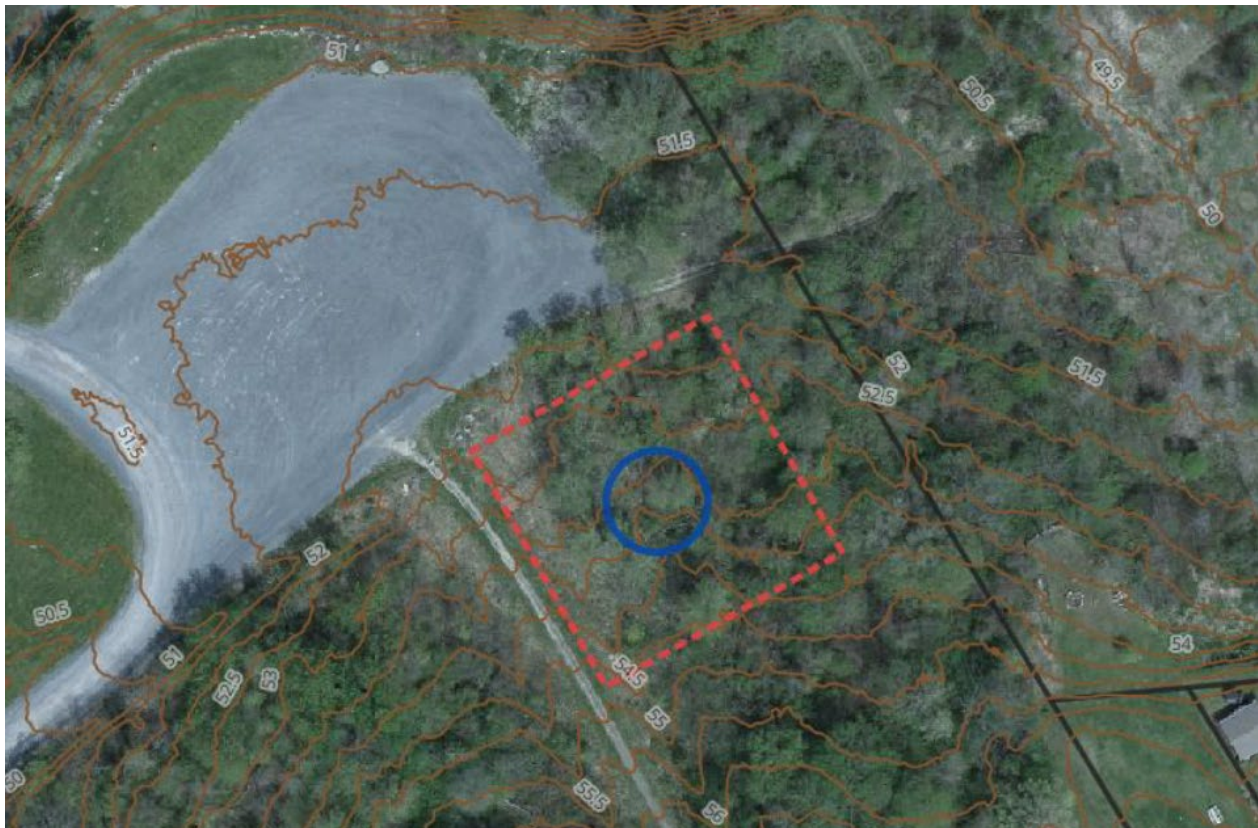
Figure 4: Location of Proposed Elevated Water Tank

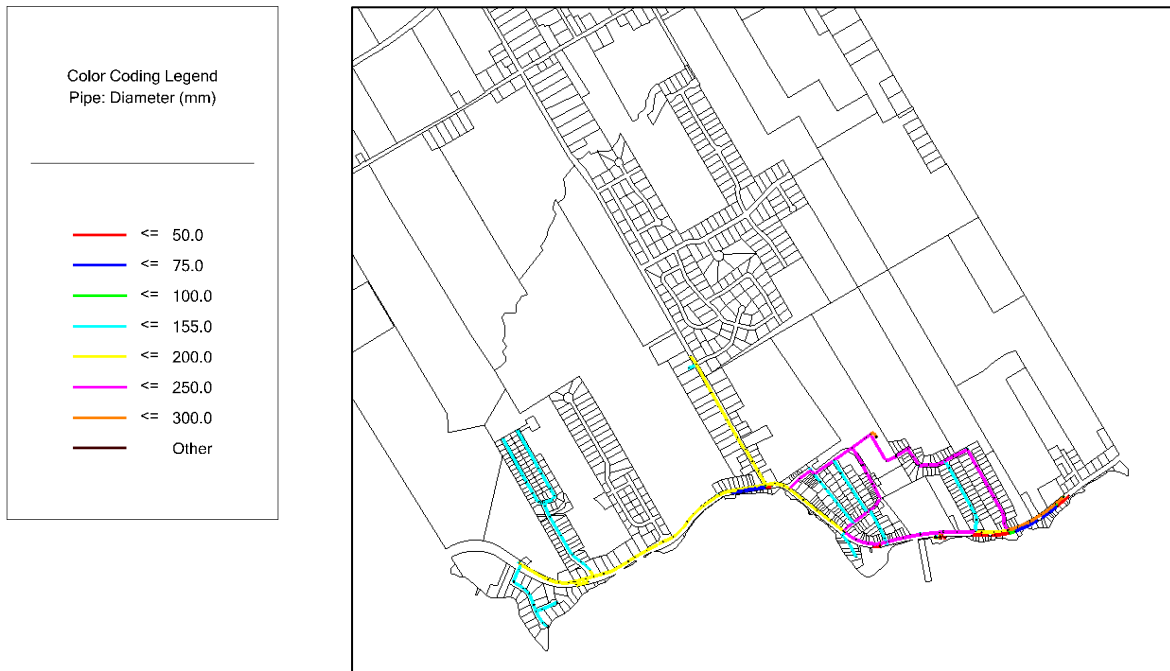
Figure 6: Existing System with Improvements – Pipe Diameters

Under this scenario, the following system improvements were identified to achieve MECP Design Guideline recommendations (see Table 2):

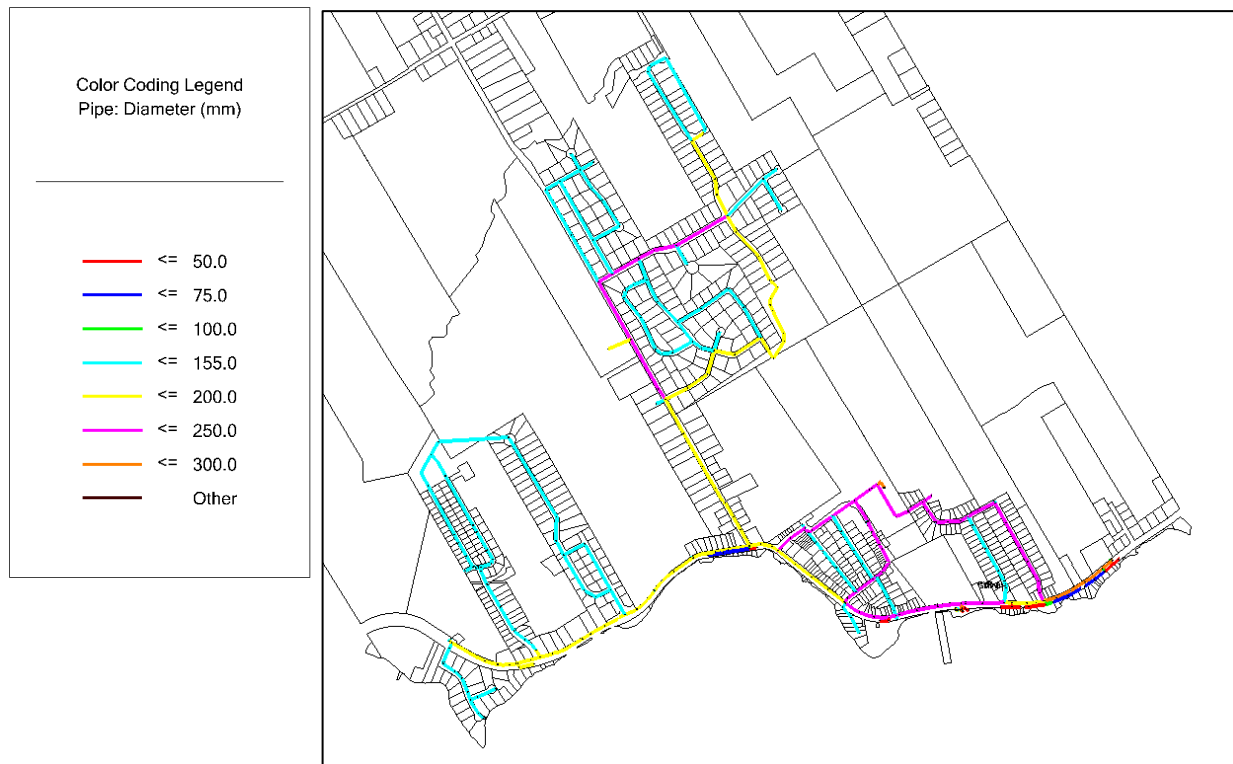
Figure 13: Future System – Supply from WTP – Diameters

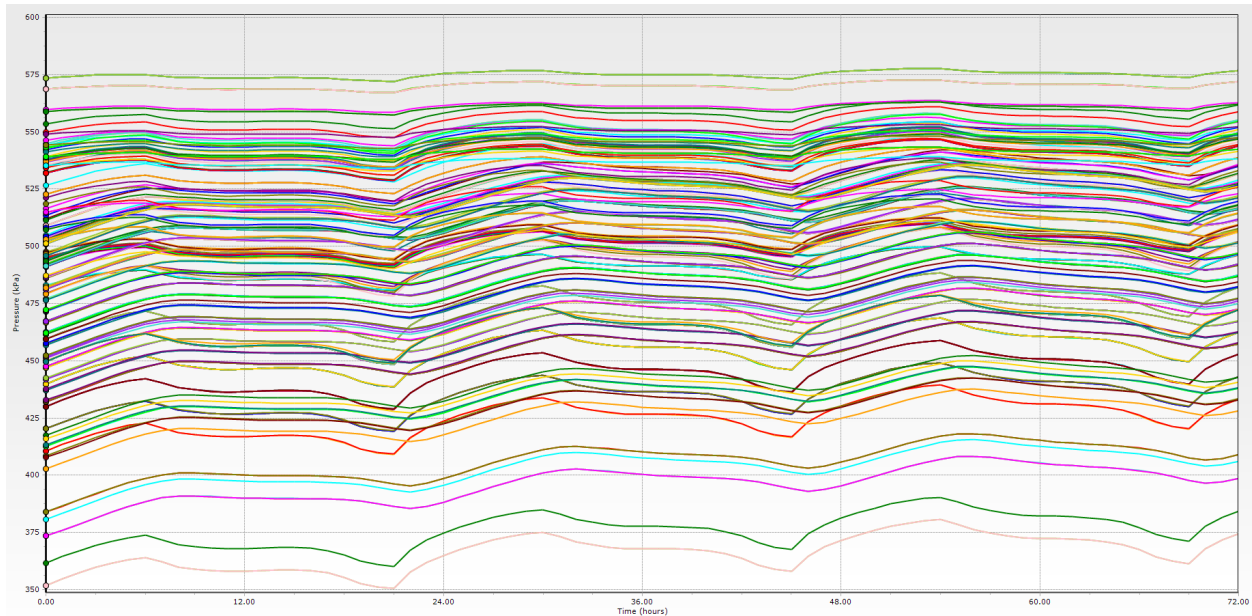
Figure 25: Future System – Supply from Cornwall – MDD EPS – Node Pressures

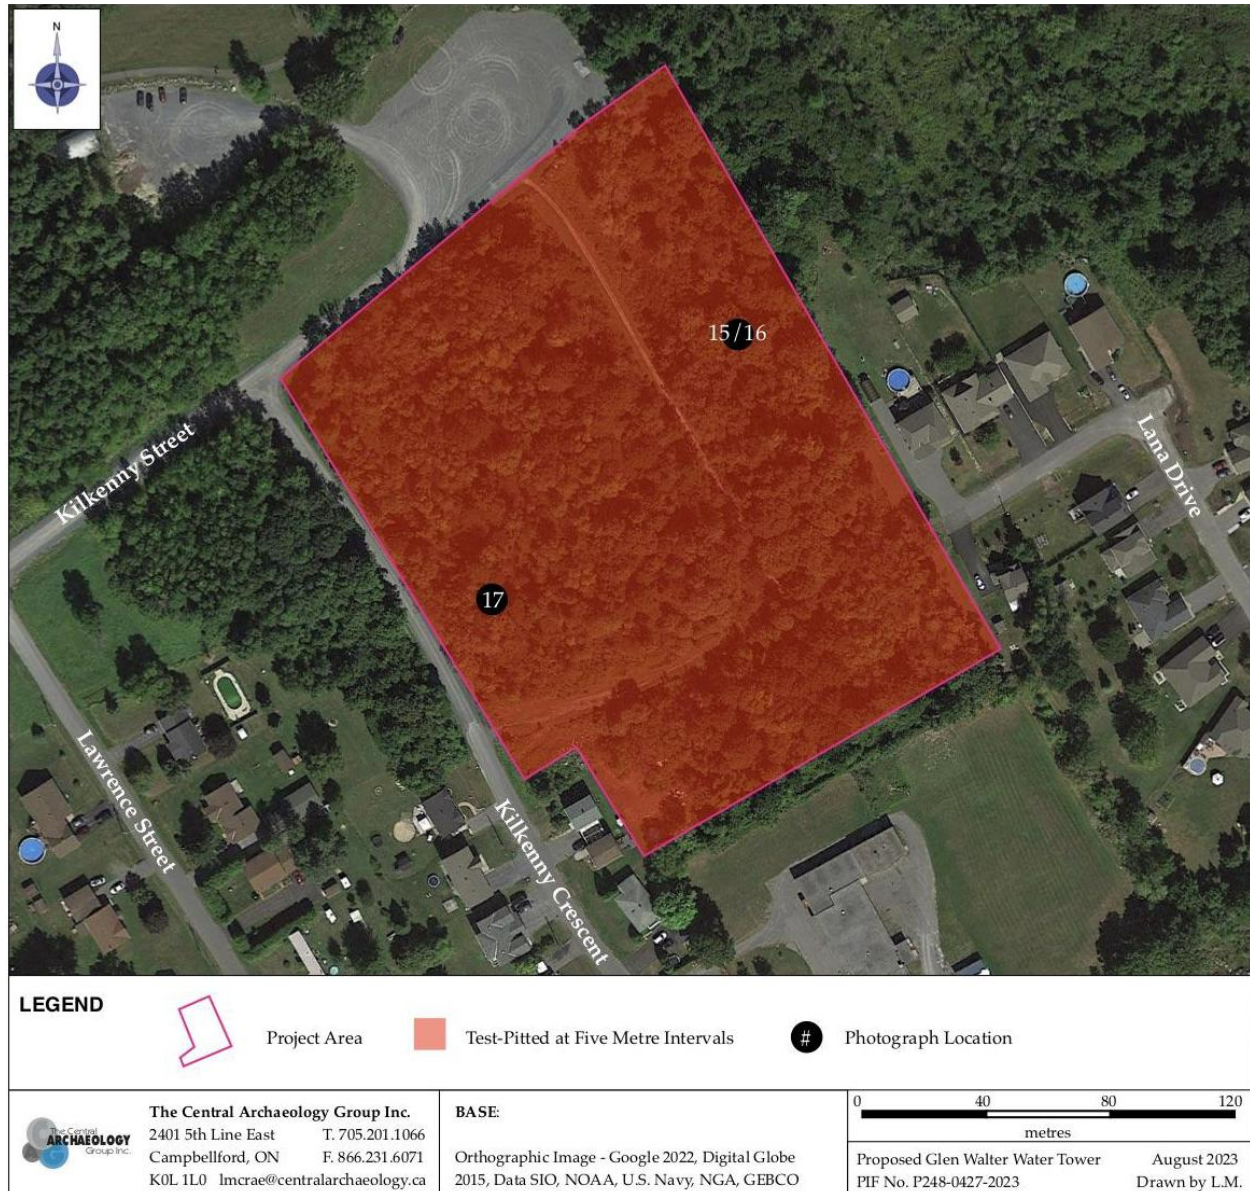
Map 12. Stage 2 property survey results.

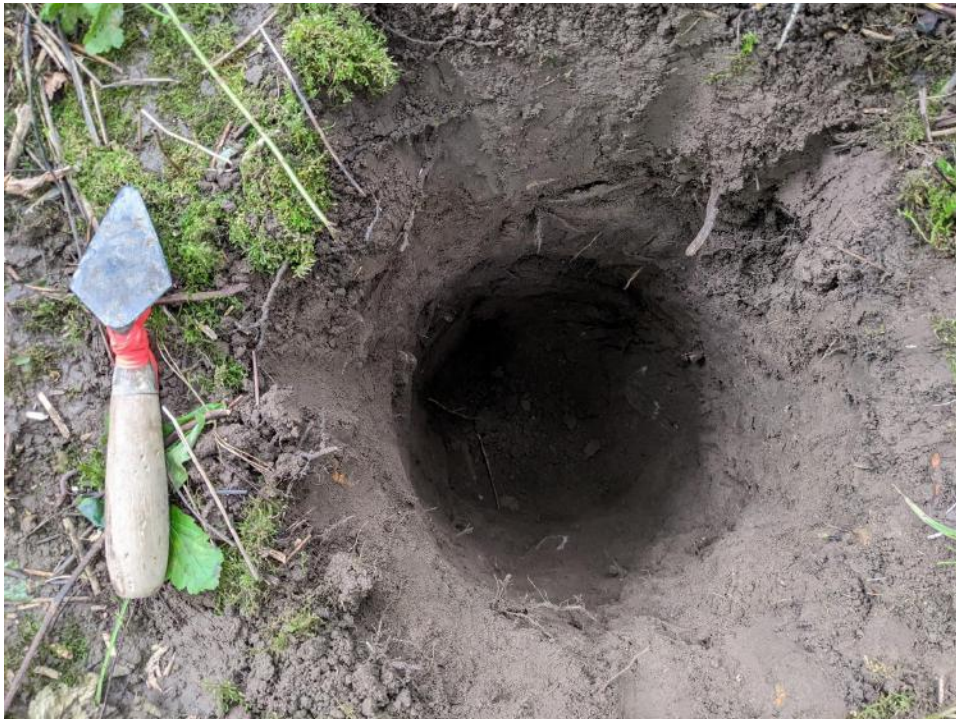
Image 15. Test pit from the northeast portion of the PA. This test pit was 65 cm deep and included three levels of stratigraphy: humus, topsoil and subsoil. The humus level was very thin at 3 cm thick. It was loosely compacted and dark grayish brown (10YR 4/2). Topsoil was 55 cm thick, moderately compacted and grayish brown (10 YR 5/2). Subsoil was yellowish brown (10YR 5/8) and moderately compacted. No cultural materials were recovered.

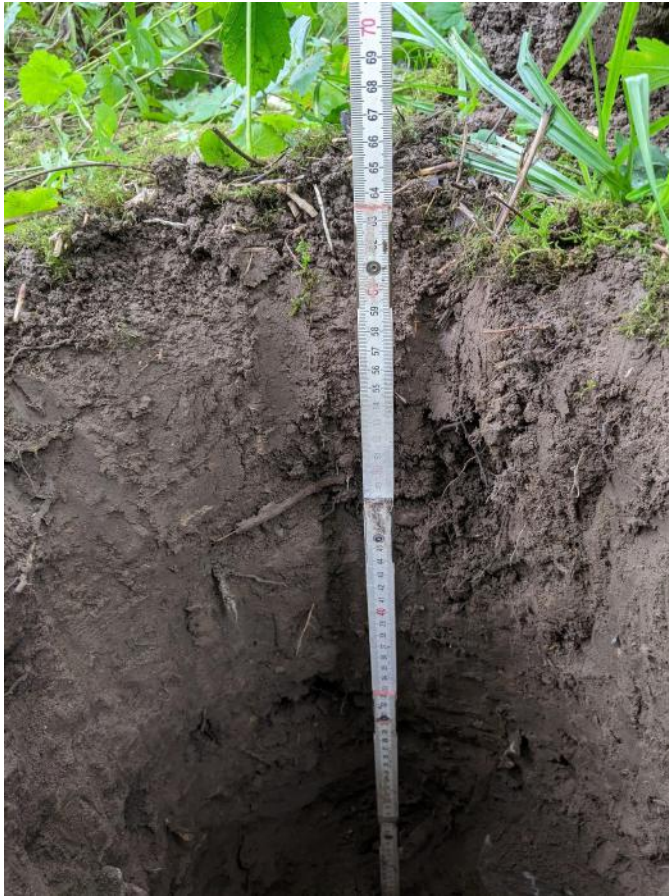
Image 16. North profile of the above test pit.

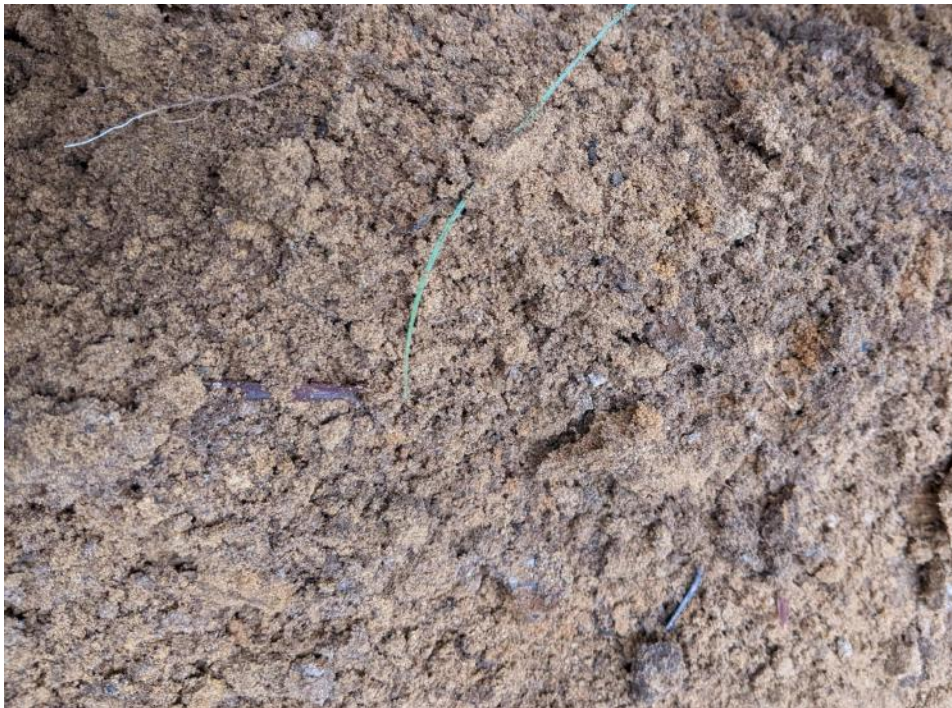
Image 17. Subsoil close-up of a test pit in the western portion of the PA.
